A Habitat Study of Created Wetland Sites in Delaware

*Delaware Department of Natural Resources and Environmental Control
Division of Watershed Stewardship
Wetland Monitoring & Assessment Program
285 Beiser Boulevard, Suite 102
Dover, DE 19904*

Haywood, B.L., Smith, K. E., Dorset, E. E., and A.B. Rogerson. 2020. A Habitat Study of Created Wetland Sites in Delaware. Delaware Department of Natural Resources and Environmental Control, Watershed Assessment and Management Section, Dover, DE. 76p.

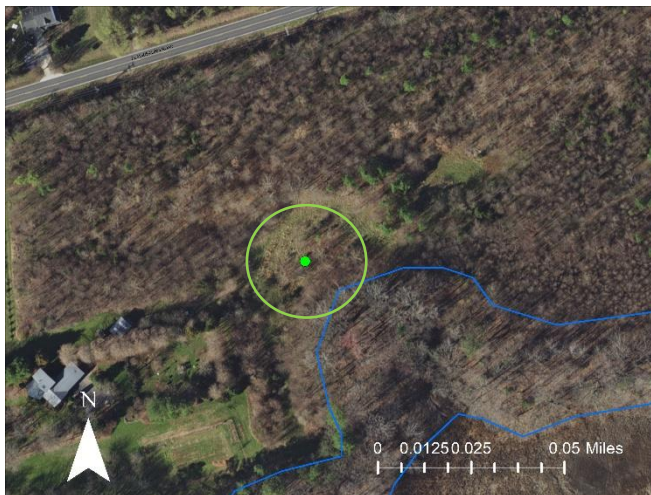
Figure 18 Zimmerman restoration site. Green dot is the assessment area center, green circle is assessment area. Blue polygon is the 2007 DE wetlands layer.

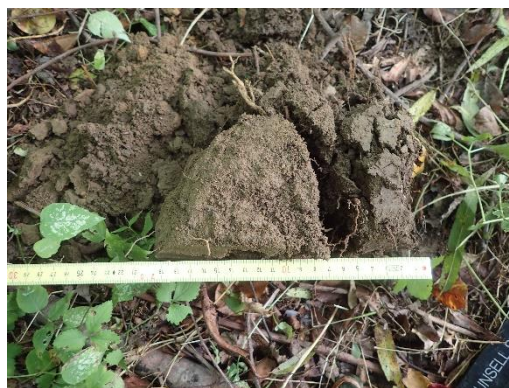
Figure 19 Soil from Zimmerman site in 2018.

As of the 2018 site visit, the Zimmerman restoration site did not contain all three wetland features. The site did not contain wetland hydrology or hydric soils but did contain hydrophytic plants. As such, the Zimmerman restoration site was not classified as a wetland for this study and no conclusions could be drawn for wetland condition. NRCS did not achieve the primary goal of creating a wetland. However, comments could be made about the existing plant community and suggestions for future improvements.

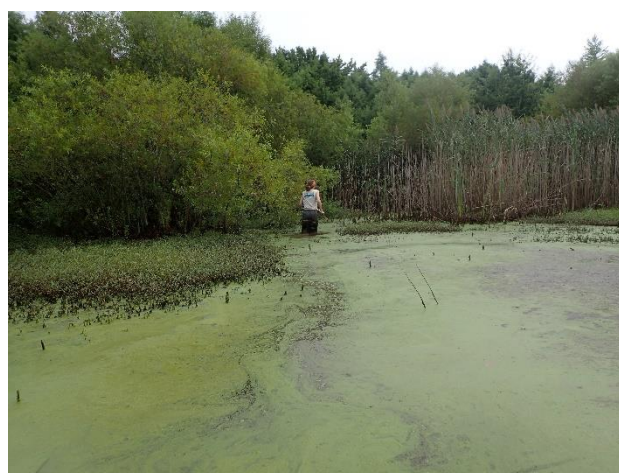
Hydrophytic vegetation was present with the dominant plant species consisting of duckweed (*Lemnoideae* spp.) and red maple (*Acer rubrum*). See plant list at end of section for complete list of plant species noted in passing. Tree age was determined to be 16-30 years with 10% forestation. The presence of invasive species was found to be 1-5% coverage with European reed

Figure 21 Little 1 assessment area, north transect in 2018.

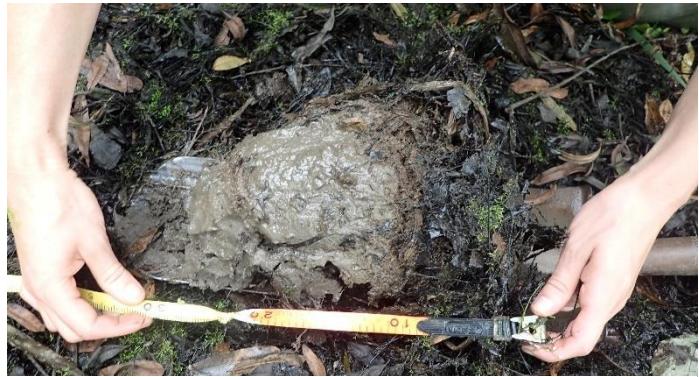
Figure 22 Little 1 soil profile in 2018.

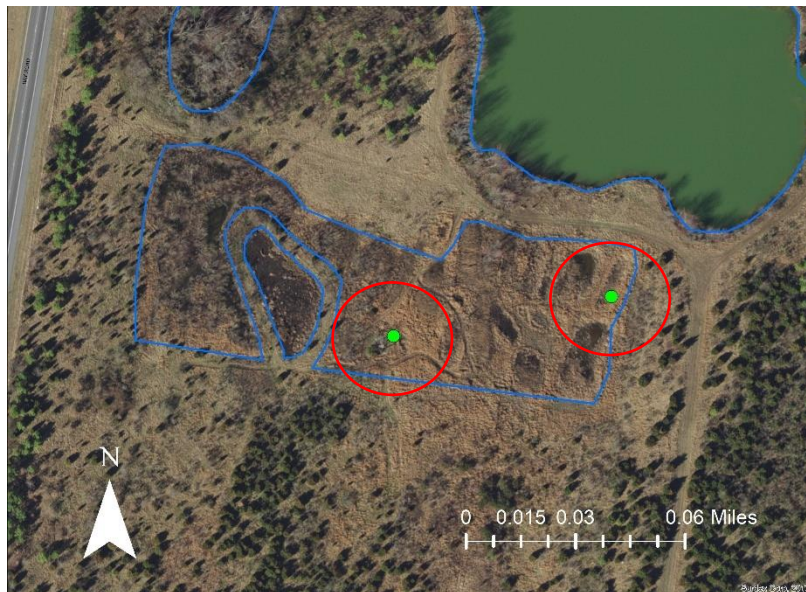
Figure 23 Island Farms wetland restoration project. 2007 mapped wetlands outlined in blue, green dots denote center and red circles denote east and west assessment areas.

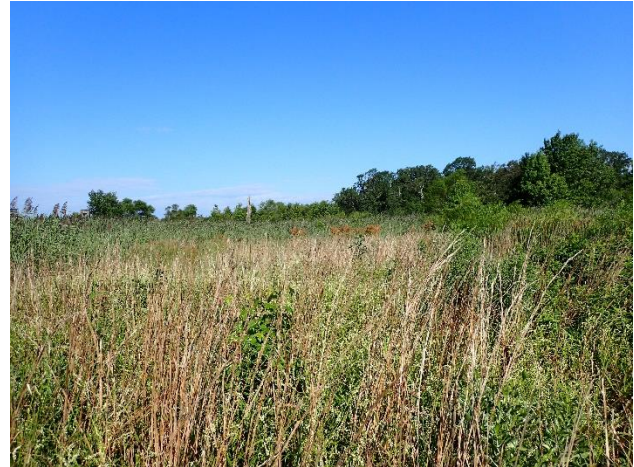
the west assessment area. The trees also appeared to be stunted. The presence of invasive species was found to be greater than 50% with autumn olive (*Elaeagnus umbellata*), bog bulrush (*Schoenoplectus mucronatus*), and European reed (*Phragmites australis* subsp. *australis*) being the prominent species in the east assessment area. In the west assessment area, the presence of invasive species was found to be 6-50%. Nutrient enrichment indicator species were determined to be present at less than 50% in both assessment sites, with flatsedge and nutsedge species (*Cyperus* spp.), narrowleaf cattail (*Typha angustifolia*), smooth rush (*Juncus effusus*), European reed (*Phragmites australis* subsp. *australis*) and black willow (*Salix negra*) being the prominent species. Horizontal vegetation obstruction was at 44% in the east assessment area. In other words, the understory was 56% open. Also worth noting was that there was a stand of dead groundsel bush (*Baccharis halimifolia*), a common tidal wetland plant, which appeared to be located in a higher/drier area of the restoration site.

Figure 24 Island Farms East assessment area on the west transect line in 2018.

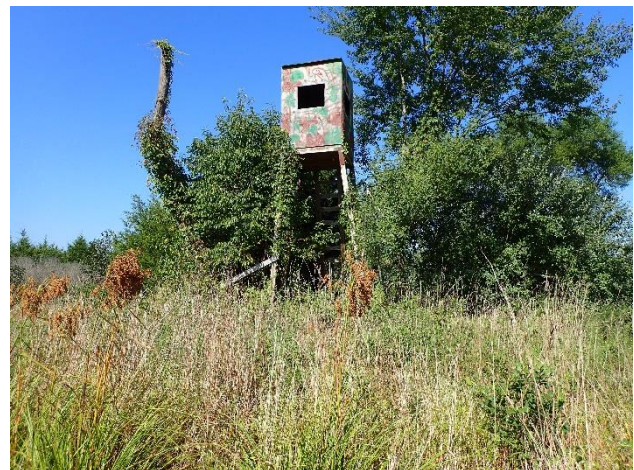
Figure 25 Island Farms West assessment area on the west transect line in 2018.

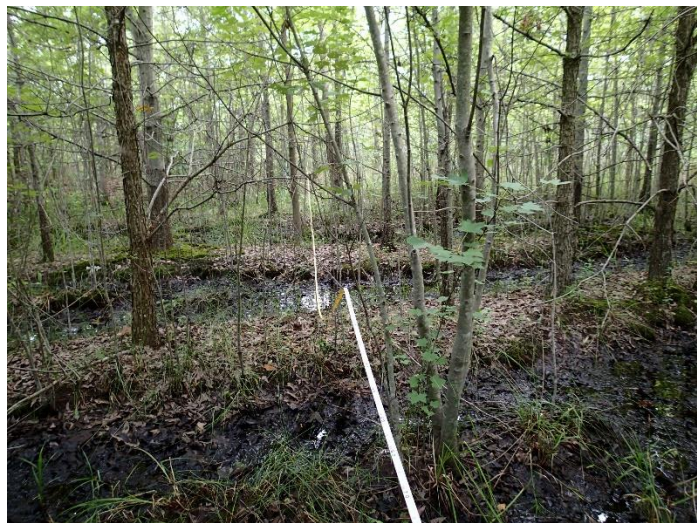
Figure 27 Scarborough assessment area, south transect in 2018.

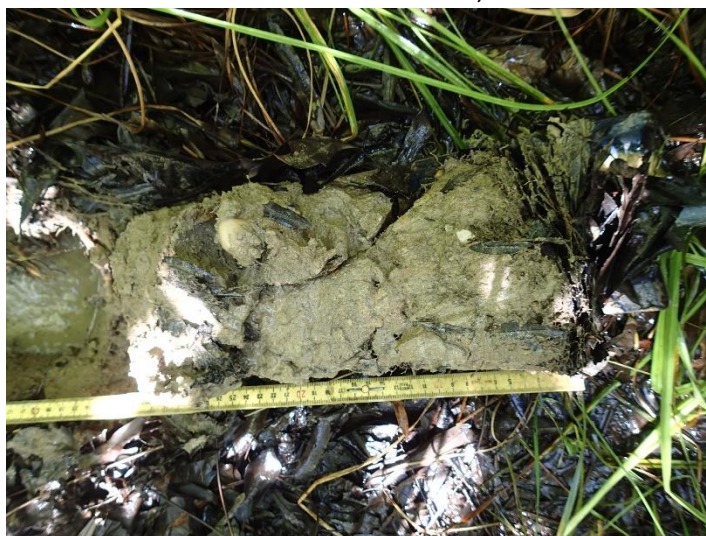
Figure 28 Scarborough soil profile in 2018.

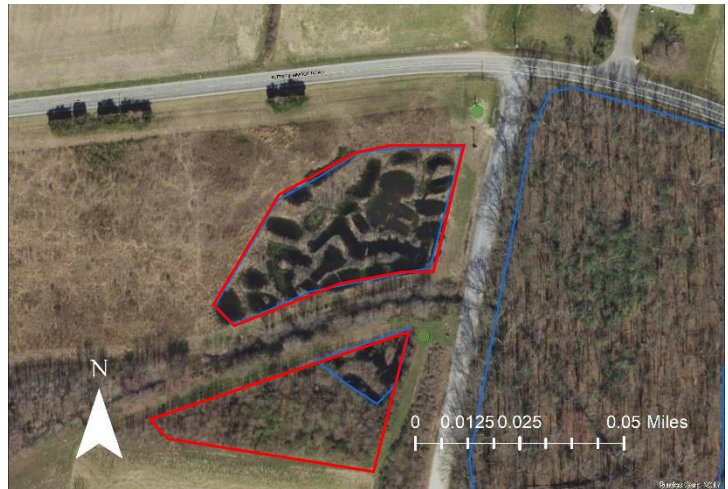
Figure 29 Ted Harvey Logan Tract Site 1 (South) and Site 2 (North). Red lines are the outlines of the assessment areas. Blue lines are 2007 mapped wetlands.

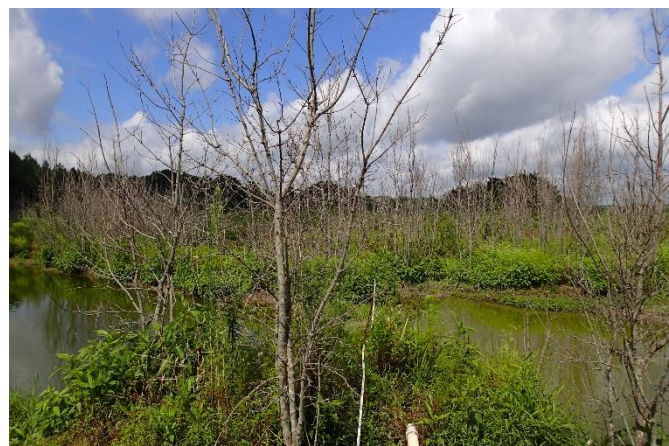
Figure 30 Ted Harvey Logan Tract 1 transect line in 2018.

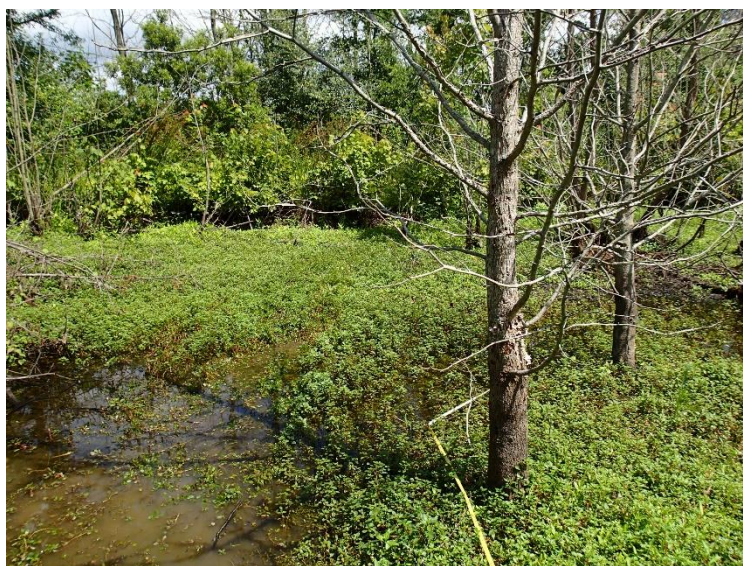
Figure 31 Ted Harvey Logan Tract 2 transect line in assessment area in 2018..

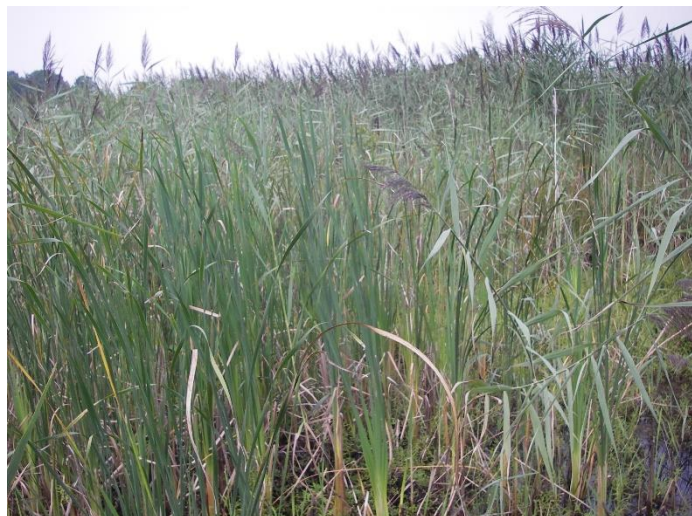
Figure 32 Ted Harvey Logan Tract 1 assessment area in 2009.

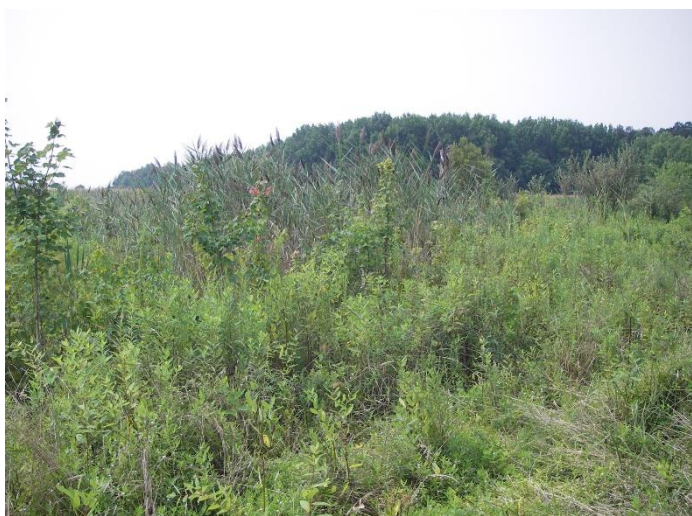
Figure 33 Ted Harvey Logan Tract 2 assessment area in 2009.

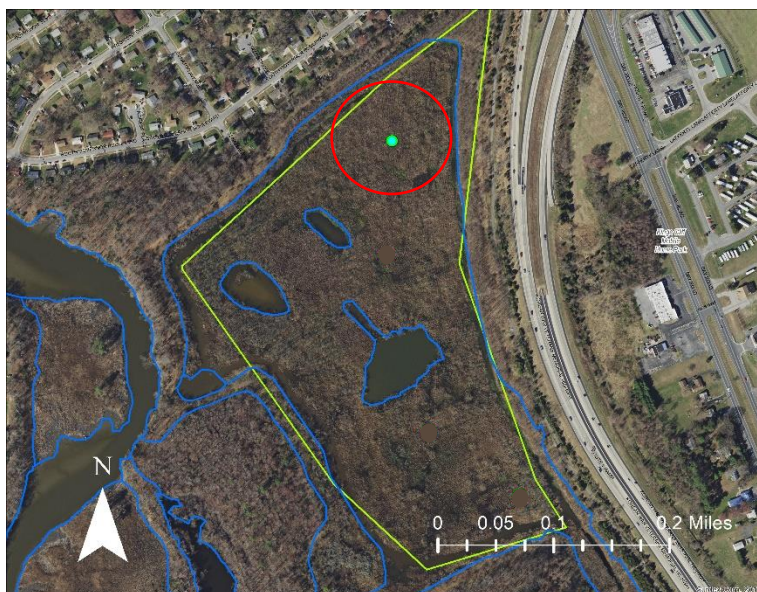
Figure 34 Island Cary wetland restoration site. Green dot represents center of assessment area, red circle represents assessment area. Green line denotes DelDOT mitigation extent, and blue line denotes 2007 mapped wetlands.

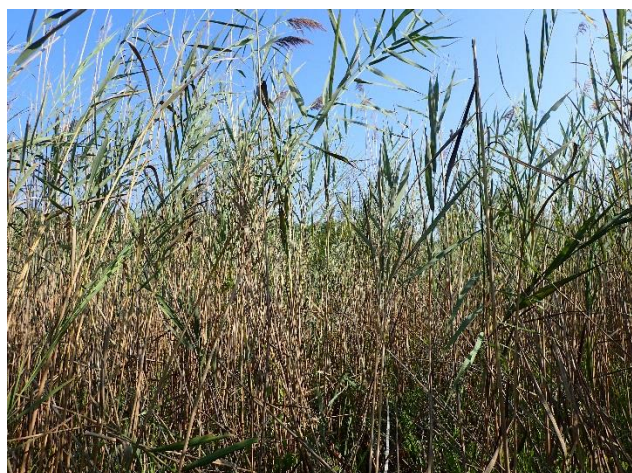
Figure 35 Island Carey 1 assessment area in 2018.

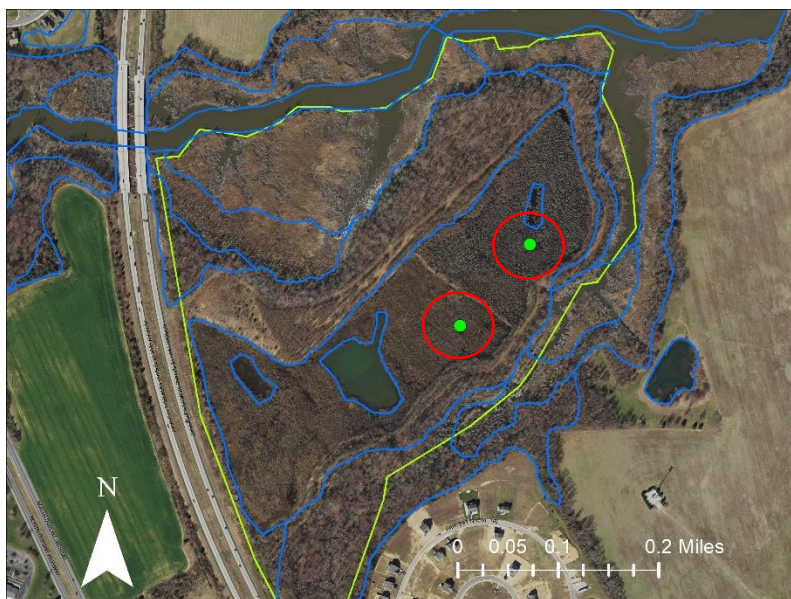
Figure 36 Pollack DelDOT wetland mitigation site, denoted by green line, Bald Cypress complex to the east and Oaks complex to the west (green dot denotes assessment area center, red circle represents approximant assessment area). Blue line is 2007 mapped wetlands.

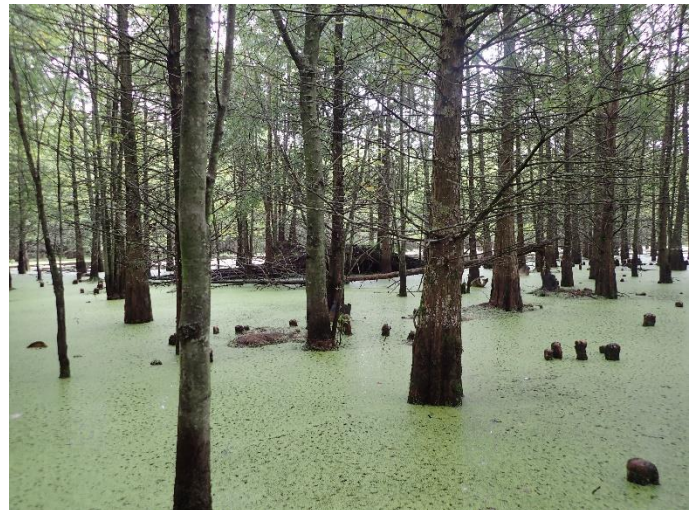
Figure 37 Pollack - Bald Cypress Complex assessment area in 2018.

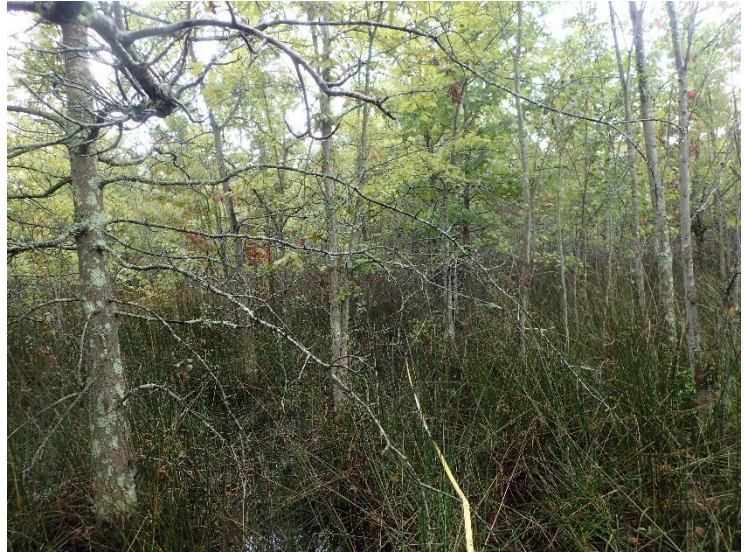
Figure 38 Pollack - Oaks Complex assessment area in 2018.

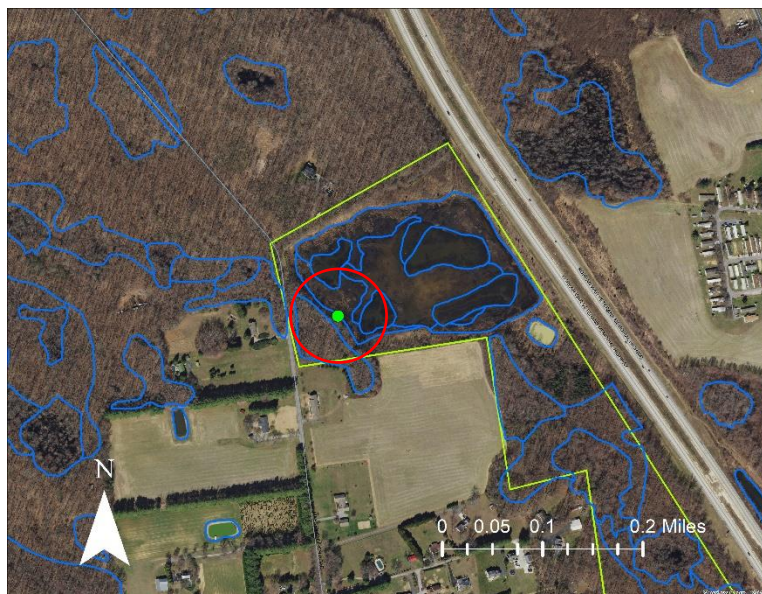
Figure 39 PNC DelDOT mitigation area (denoted by green line). Green dot denotes assessment area center, red circle denotes approximate assessment area, and blue lines highlighted 2007 mapped wetlands.

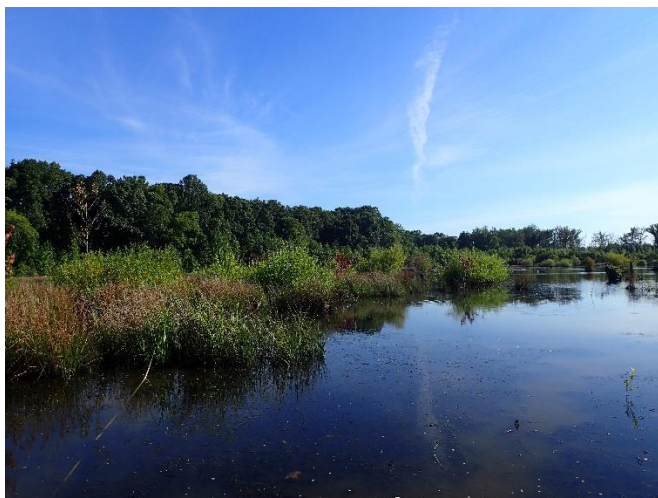
Figure 40 PNC assessment area in 2018.

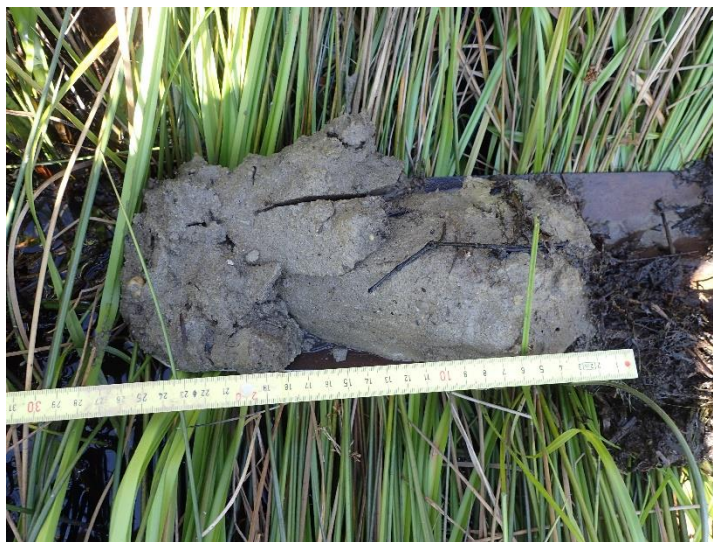
Figure 41 PNC soil profile in 2018.

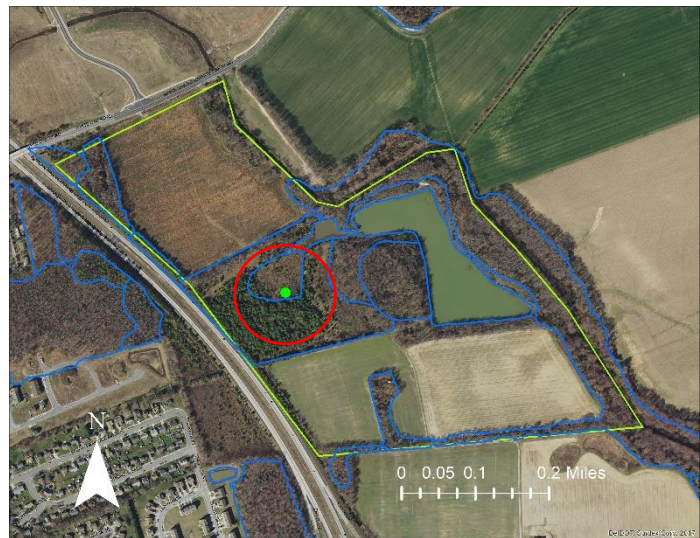
Figure 42 Thompsonville Cartanza DelDOT mitigation site outlined in green. Green dot is center of assessment area, red circle is approximate assessment area, and blue lines denote 2007 mapped wetlands.

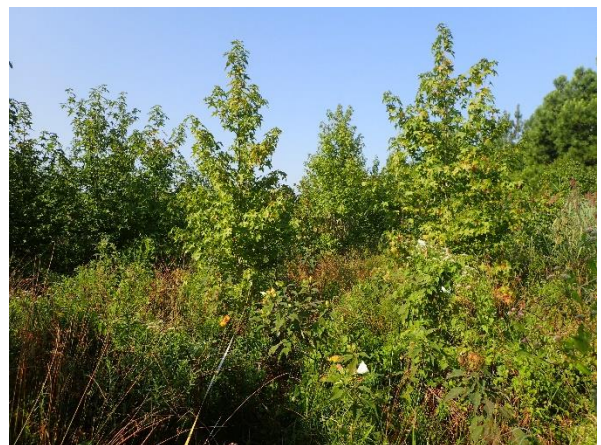
Figure 43 Thompsonville Cartanza transect line through assessment area in 2018.

indicator species were also found, but since this wetland was assessed as a flat this metric was not scored (DERAP, 2010). Nutrient enrichment indicator species found included: smooth rush (*Juncus effusus*), smartweeds (*Persicaria spp.*), algae, rice cutgrass (*Leersia oryzoides*), European reed (*Phragmites australis* subsp. *australis*), and barnyard grass (*Echinochloa crus-galli*). Horizontal vegetation obstruction was at 42%. In other words, the understory in this wetland was 58% open.

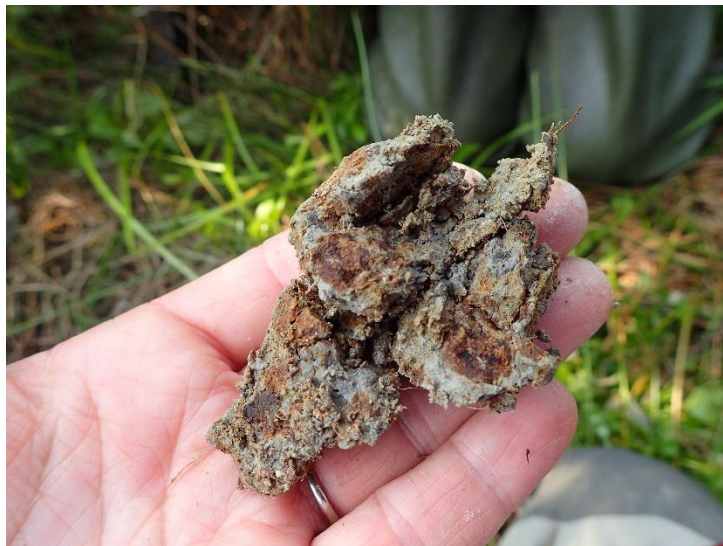
Figure 44 Thompsonville Cartanza, redox features from soil profile in 2018 sample.

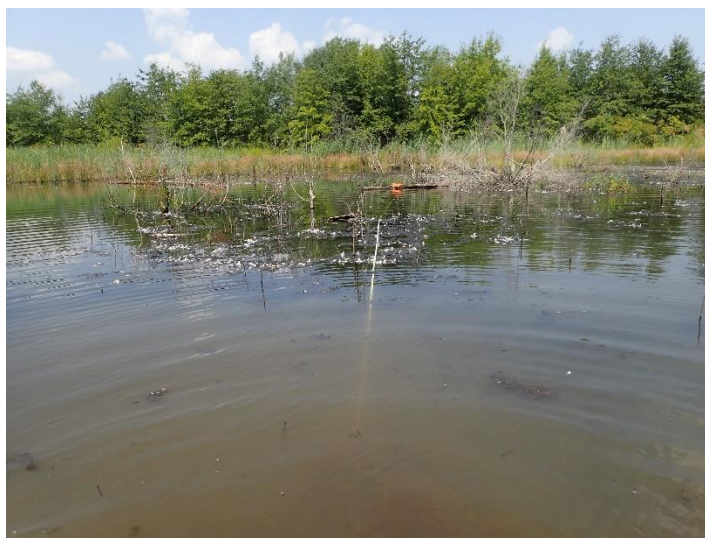
Figure 46 Poplar Hill, transect line in assessment area in 2018.

australis subsp. *australis*) being the prominent species. Nutrient enrichment indicator species were estimated at 0% coverage, yet notation of smooth rush (*Juncus effusus*) and European reed (*Phragmites australis* subsp. *australis*) species was made. Horizontal vegetation obstruction could not be performed due to water levels.

Therefore, if an interest in improving the functional capacity of Poplar Hill is desired, we recommend efforts to re-introduce annual hydrologic variability, additional microtopography or habitat features such as large downed wood and replant the site with vegetation capable of sustaining through long periods of inundation. These changes could allow this site to become a finely tuned feature for improving water quality and reducing greenhouse gas emissions in a developed landscape.

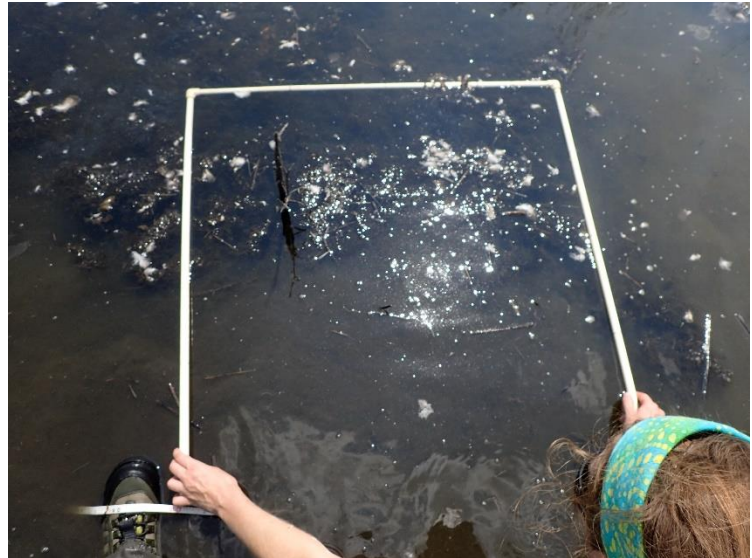
Figure 47 Poplar Hill plot in 2018 assessment. Note the abundance of feathers on water's surface.

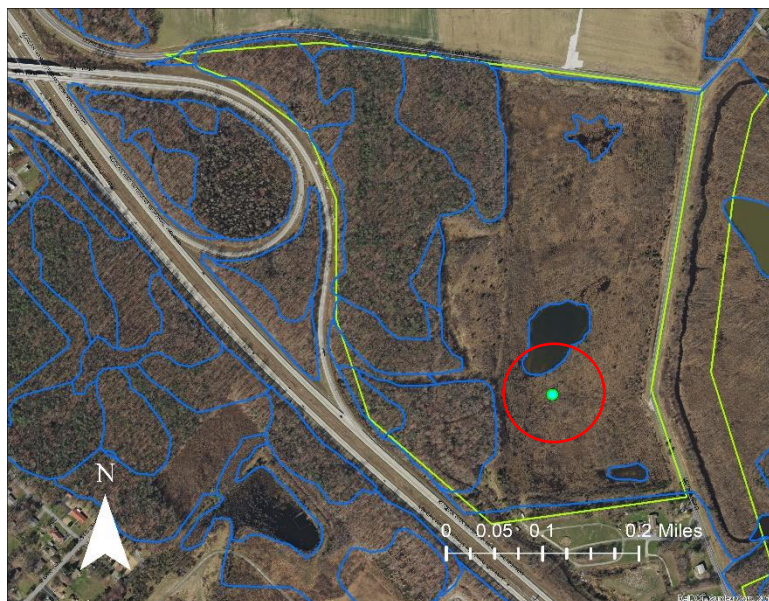
The David site was located on state property in the Leipsic River Watershed and was created in the 1992. The project was managed by the Delaware Department of Transportation (DelDOT) as a mitigation project to offset the damages to wetlands that occurred during the creation of State Route 1 (SR1). The site was a wet meadow that was approximately 2m lower than the road elevation and surrounded by a berm that impounds water. Oak trees were planted in strips on the mounds of the skidder tracks. These tracks encompass the whole site, and in 2018 the only standing water was in the skidder ruts.

Figure 48 David DeIDOT mitigation site, outlined in green. Green dot denotes center of assessment area, and red circle denotes approximate assessment area. Blue lines mark 2007 mapped wetlands.

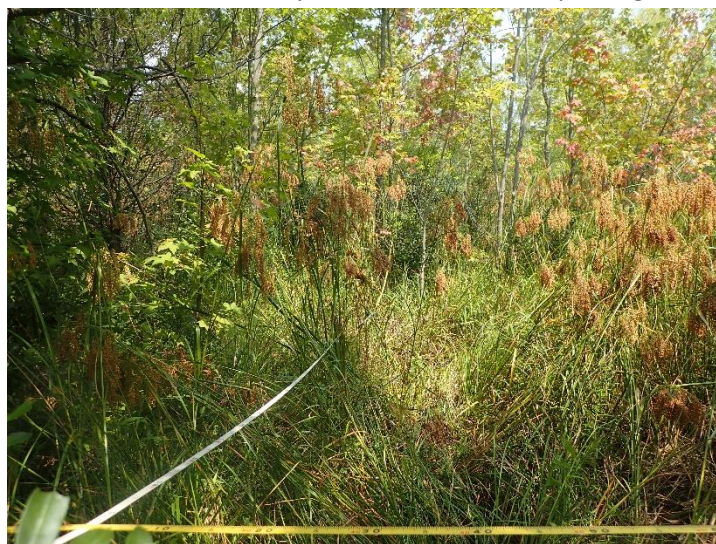
Wetland hydrology was classified as present through the indicators of surface waters contained in skidder ruts. The site assessment area had an average water depth of 0.88cm and was 1-25% permanently flooded and inundated at 26-50%.

Figure 49 David assessment area in 2018.

Hydrophytic vegetation was present. The dominant plant species seen in the assessment area were swamp chestnut oak (*Quercus michauxii*), and red maple (*Acer rubrum*). See plant list at end of section for plant species noted in passing. Tree age was determined to be 16-30 years with 100% forestation. The presence of invasive species was found to be 6-50% with European reed (*Phragmites australis* subsp. *australis*), purple loosestrife (*Lythrum salicaria*) and narrowleaf cattail (*Typha angustifolia*) being the prominent species. Nutrient enrichment indicator species were estimated at 0% coverage as this parameter only applied to depression wetlands in DERAP. Although, the following species found at this site are considered to be nutrient enrichment indicator species in depressions: smooth rush (*Juncus effusus*), European reed (*Phragmites australis* subsp. *australis*), dotted smartweed (*Persicaria punctata*), and narrowleaf cattail (*Typha angustifolia*). Horizontal vegetation obstruction was at 33%. In other words, the understory in this wetland was 67% open.

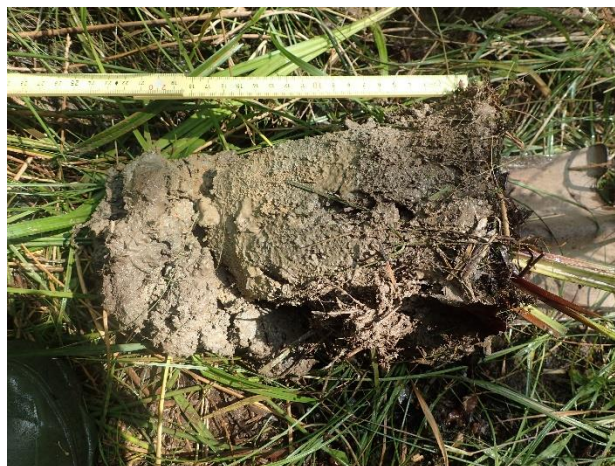
Figure 50 David soil profile in 2018.

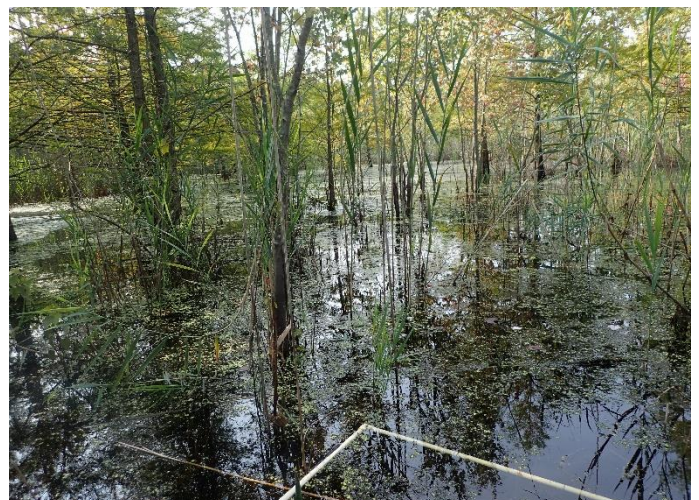
Figure 52 Sarro assessment area in 2018.

Tree age was determined to be 16-30 years with 80% forestation. The presence of invasive species was found to be 6-50%, with European reed (*Phragmites australis* subsp. *australis*) being the prominent species. Nutrient enrichment indicator species were estimated at less than 50% coverage with smooth rush (*Juncus effusus*) and European reed (*Phragmites australis* subsp. *australis*) being the dominant species. Horizontal vegetation obstruction was at 39%. In other words, the understory in this wetland was 62% open.

Therefore, if an interest in improving Sarro is desired, we recommend efforts to re-introduce annual hydrologic variability, additional microtopography or habitat features such as large downed wood and/or course woody debris, and management of the invasive species. These changes could allow this site to become a finely tuned feature for improving water quality and providing wildlife habitat.

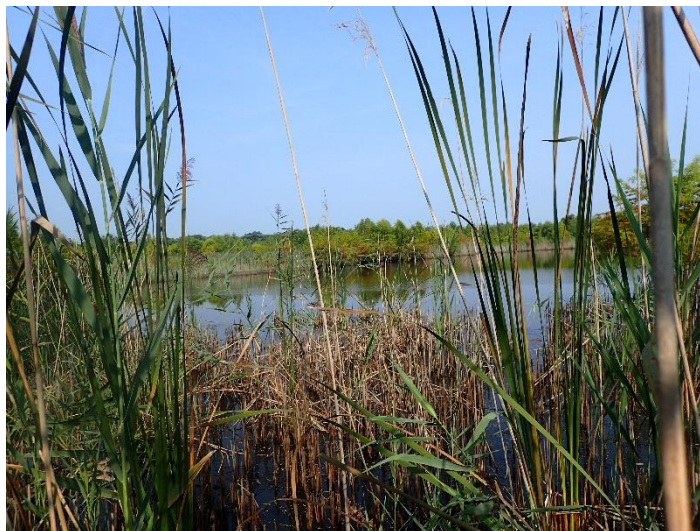
Figure 53 View of pond, west of the Sarro assessment area.

But, as the average standing water over assessment area was over 30cm and appears to remain at this level, questions remain as to how effective this ponded wetland is in providing ecoservices such as improving water quality or reduces the effects of climate change. While vegetated ponds do perform water quality improving functions, there is research that suggests that ponds with stagnate do not have the necessary features to effectively reduce nutrient loads and total suspended sediments (Wong, 1999). It has also been suggested that varying water levels throughout the year can promote vegetation growth or regrowth, and aide in combating climate change through reduced methane emissions (Aaron, 2007, Altor, 2006 and Keddy, 2000)

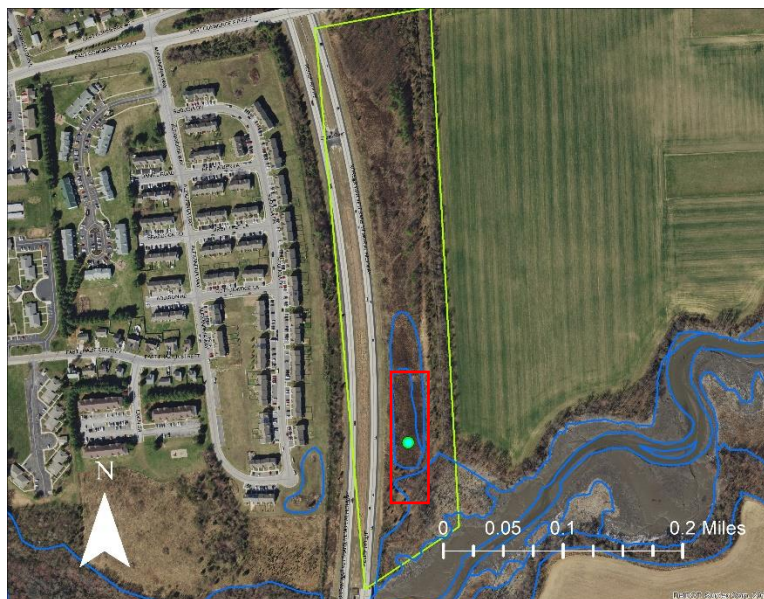
The Hall site was located on state property in the Smyrna River Watershed and was created in 1998. The project was managed by the Delaware Department of Transportation (DelDOT) as a mitigation project to offset the damages to wetlands that occurred during the creation of State Route 1 (SR1). The site was a depression type wetland that is enveloped by berm. SR1 borders the site to the west, and an agricultural field borders the site to the east. The site contained a natural-looking unidirectional overflow that drains into Mill Creek. Standing water was present across the entire site.

Figure 54 Hall DelDOT mitigation site outline in green. Green dot denotes center of assessment area, red rectangle denotes approximate size of assessment area. Blue lines outline 2007 mapped wetlands.

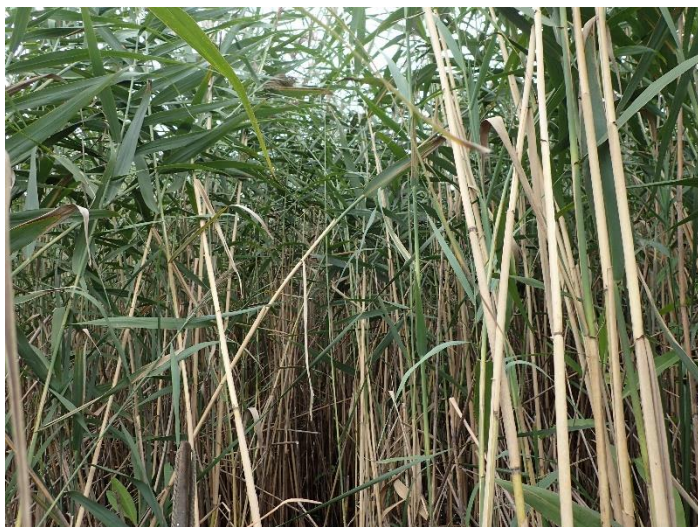
Wetland hydrology was classified as present through the indicators of surface waters that averaged to be 23.00cm deep across the assessment area. The site was greater than 75% permanently flooded and inundated at greater than 75%.

Hydrophytic vegetation was present. No dominant plant species were recorded in assessment area, although open water was a high occurrence. See plant list at end of

Figure 55 Hall assessment area, north transect line in 2018.

If improvements to the Hall site are desired, we recommend efforts to manage the abundant invasive species present.

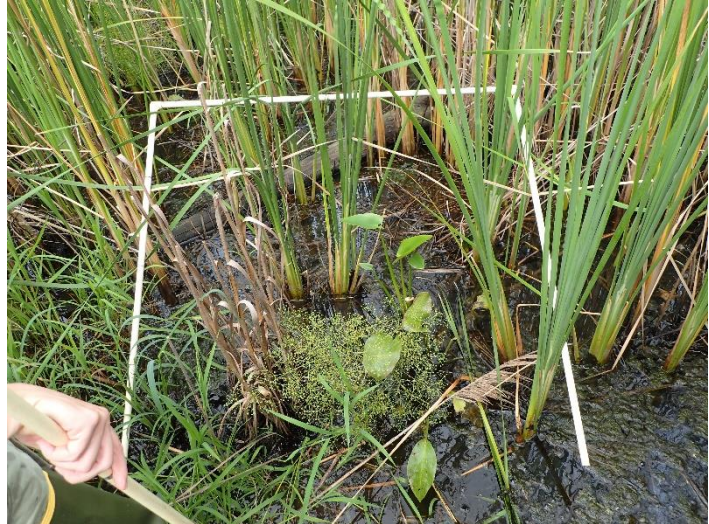
section for plant species noted in passing. Tree age was determined to be 3-15 years with 1% forestation. The presence of invasive species was found to be greater than 50% with European reed (*Phragmites australis* subsp. *australis*) and narrowleaf cattail (*Typha angustifolia*) being the prominent species. Nutrient enrichment indicator species were estimated at greater than 50% coverage with smooth rush (*Juncus effusus*), European reed (*Phragmites australis* subsp. *australis*), narrowleaf cattail (*Typha angustifolia*), and smartweeds (*Persicaria* spp.) being the dominant species. Algae were also present. Horizontal vegetation obstruction was at 45%. In other words, the understory in this wetland was 56% open.

Figure 56 Hall vegetation plot in 2018.

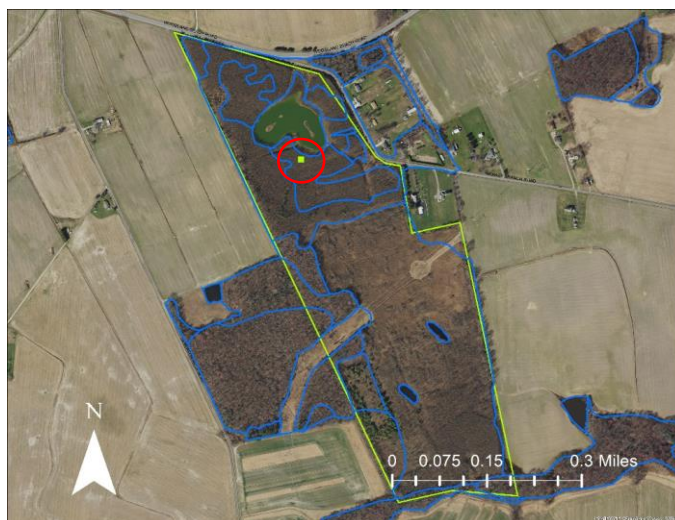
The Hurd site was located on state property in the Smryna River Watershed and was created in the 1998. The project was managed by the Delaware Department of Transportation (DelDOT) as a mitigation project to offset the damages to wetlands that occurred during the creation of State Route 1 (SR1). The site was a forested flat type wetland that is connected to a pond and was created on a previously agricultural site. Agricultural fields and houses border the site on all sides. Standing water was present across the entire site.

Figure 57 Hurd DelDOT mitigation site outlined in green. Green dot denotes assessment area center, red circle denotes approximate assessment area. Blue lines outline 2007 mapped wetlands.

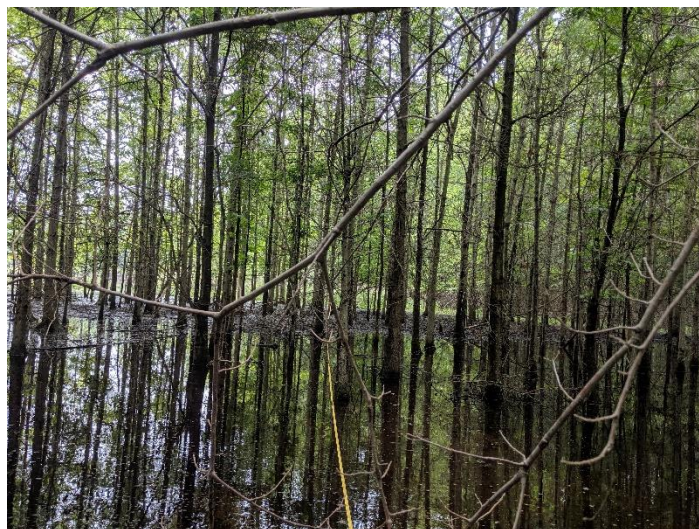
Hydrophytic vegetation was present with the dominant vegetation consisting of willow oak (*Quercus phellos*), and pin oak (*Quercus palustris*). See plant list at end of section for plant species noted in passing. Tree age was determined to be 16-30 years with 100% forestation. The presence of invasive species was found to be 1-5% with European reed (*Phragmites australis* subsp. *australis*) being

Figure 61 Hurd, east transect line in the assessment area in 2019.

the prominent species. Nutrient enrichment indicator species were recorded at 0% since this was assessed as a flat wetland, although European reed (*Phragmites australis* subsp. *australis*) is considered a nutrient enrichment indicator species. Horizontal vegetation obstruction was at 12%. In other words, the understory in this wetland was 88% open.

The presence of invasive species was minimal, but to ensure that it does not take over the restoration project, we recommend the continual monitoring and or management of the invasive species.

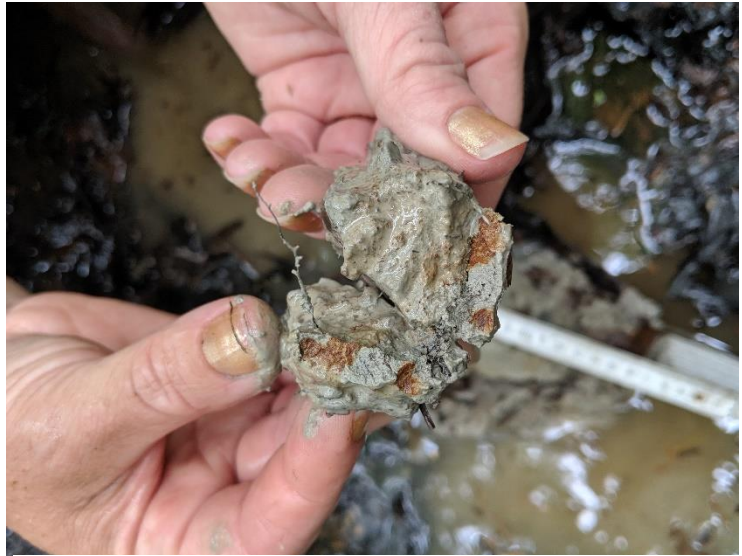
Figure 62 Redox features from soil profile of Hurd site in 2019.
